**LOWER DRESSER NO. 4 DAM
WASHINGTON COUNTY, MISSOURI
MO 31123**

**PHASE I INSPECTION REPORT
NATIONAL DAM SAFETY PROGRAM**

PREPARED BY
INTERNATIONAL ENGINEERING COMPANY, INC.
CONSULTING ENGINEERS
SAN FRANCISCO, CALIFORNIA

JUNE 1979

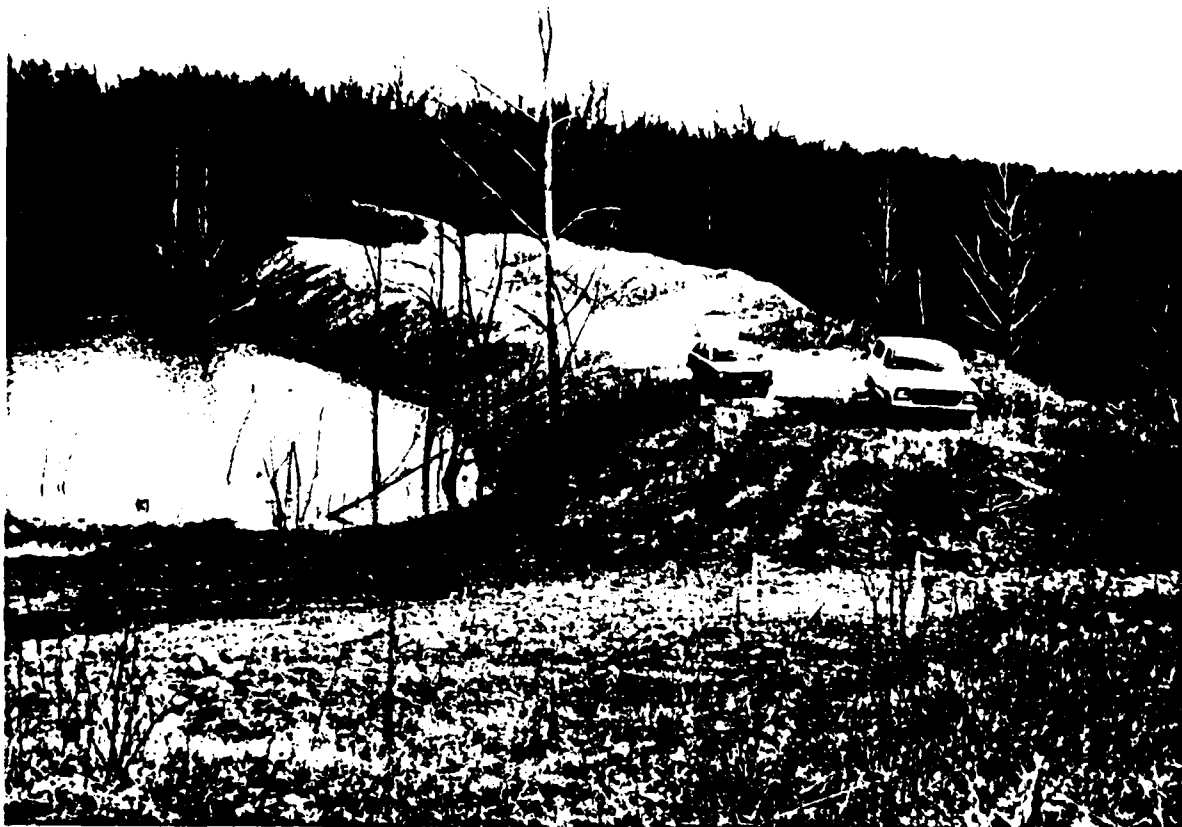
OVERVIEW OF LOWER DRESSER NO. 4 DAM
FROM RIGHT ABUTMENT

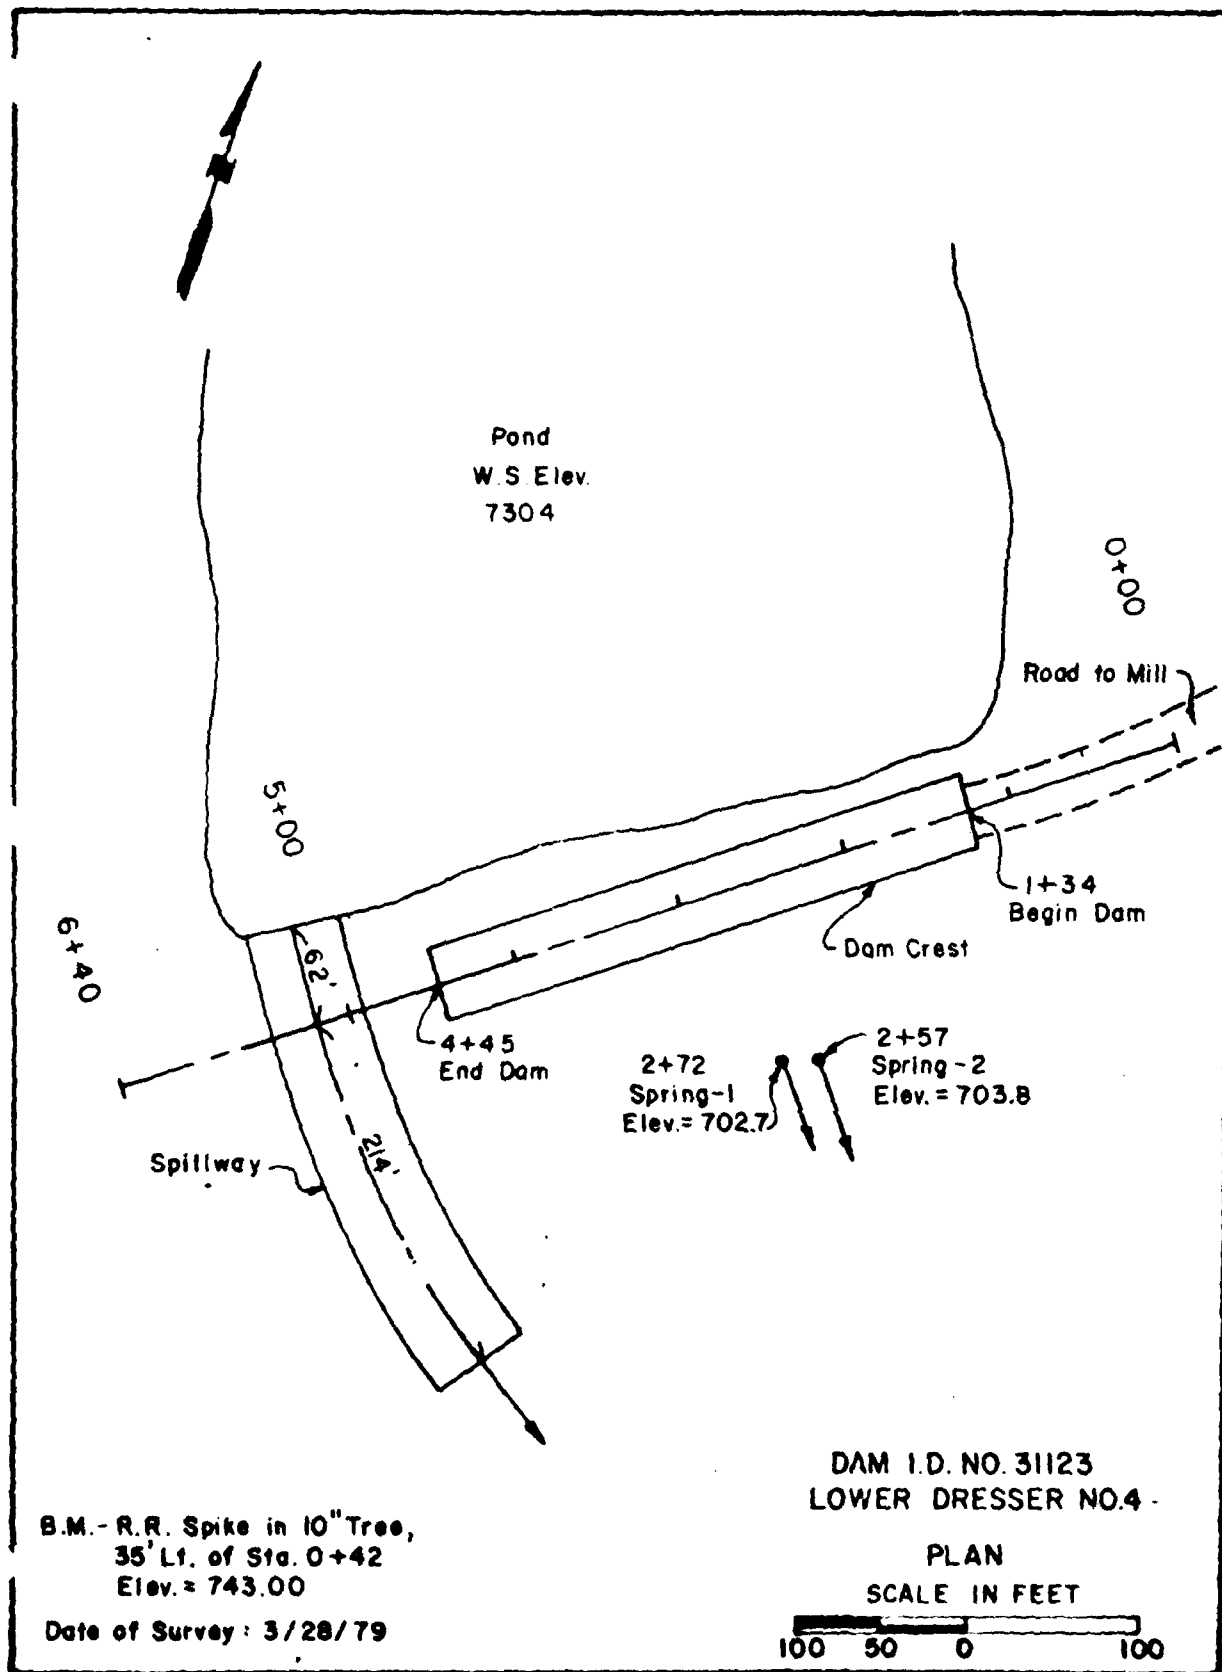
PLATE 3

Two springs were observed at the maximum section of the dam at the downstream toe. The springs are approximately 15 feet apart and are shown on the plan of the dam, Plate 3. At the time of the inspection, the flow from Spring No. 1 was estimated to be 15 to 25 gpm. Spring No. 2 was flowing at an estimated rate of about 5 gpm. The ground was firm at both springs. The flow from both springs was clear and there was no evidence of piping. Some vegetation and trees are growing in the channels where the springs emerge from the dam.
